# Walk Around

## F-8 Crusader

Walk Around Number 38  
squadron/signal publications

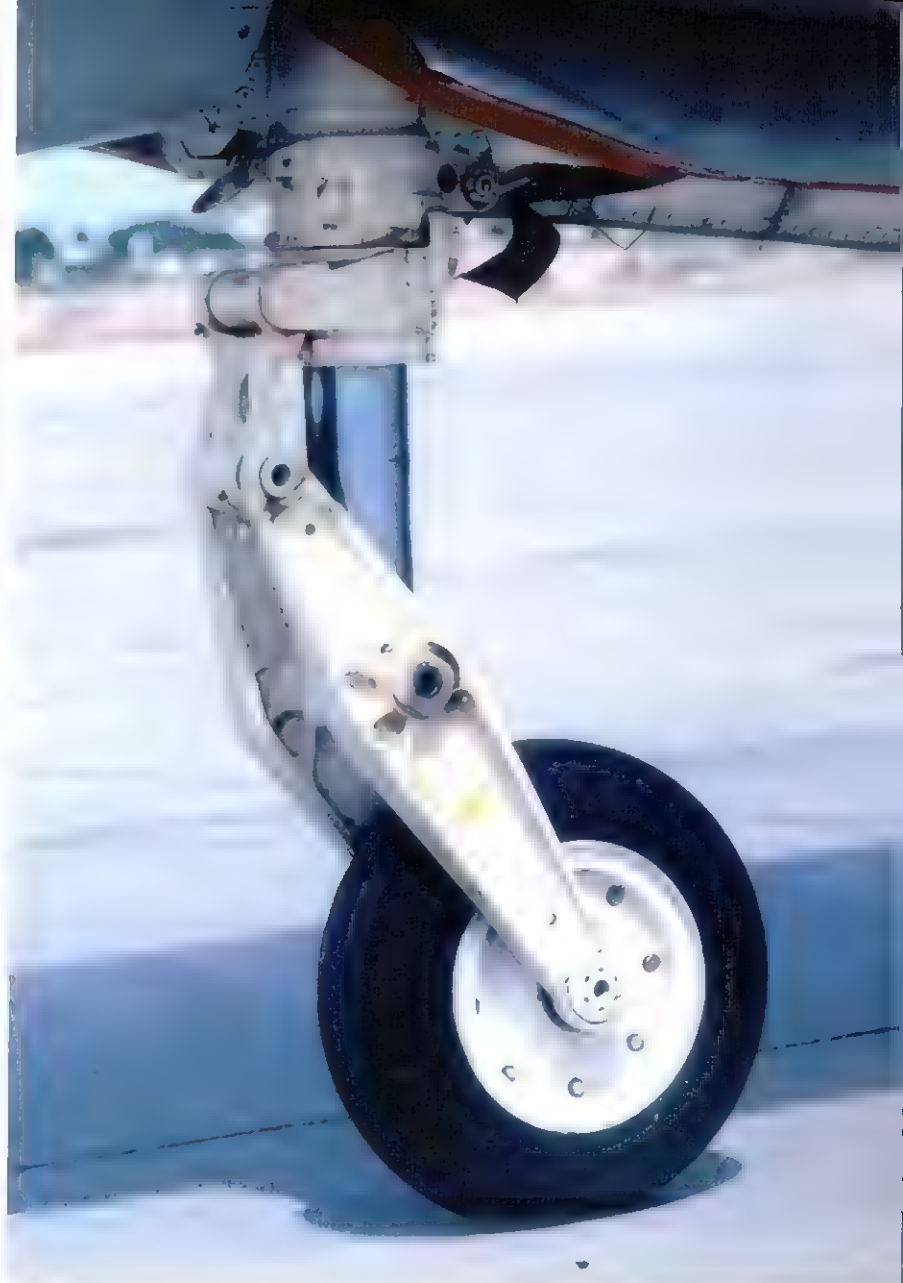
The RF-8's nose landing gear development followed the same progression as on the F-8 fighters. This RF-8G has fully extended the later style gear, which is easily identified by the 'skid horns' mounted on the front of the upper gear strut section. A yellow anchor painted high on the strut indicated where to place a chain for securing the aircraft to the ground or carrier deck. (Trombecky)

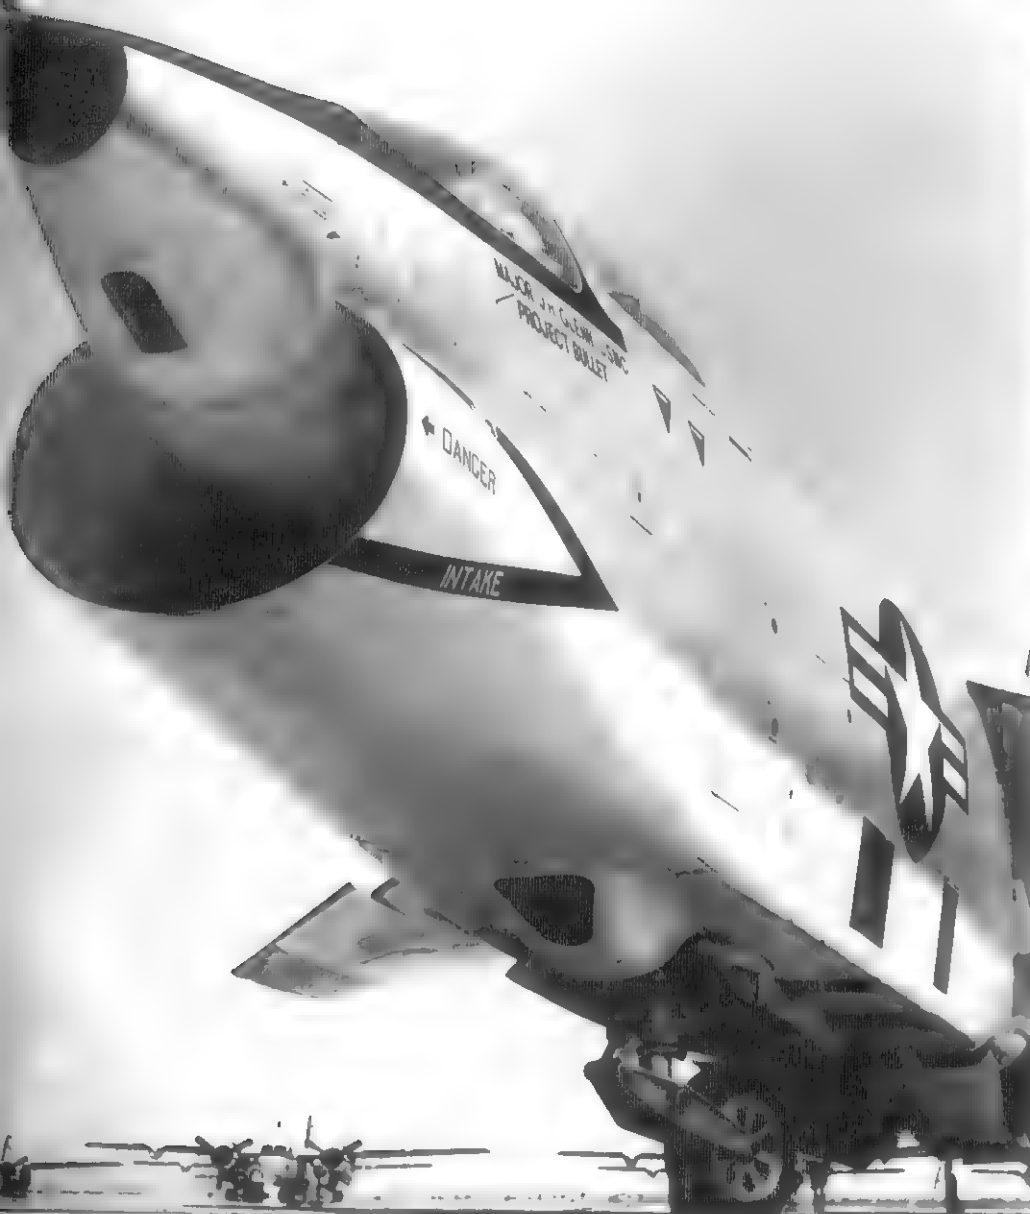
Major John Glenn's Project BULLET F8U-1P sits on the NAF Floyd Bennett Field ramp after completing its 1957 record-setting transcontinental flight. The squared off under-surface provided a flat surface for the vertically mounted cameras' optical panels. Camera station 1 was located in a teardrop-shaped fairing located on the forward fuselage, immediately in front of the nose landing gear. Early Crusader reconnaissance aircraft had the spoked-style nose wheel. (Vought)

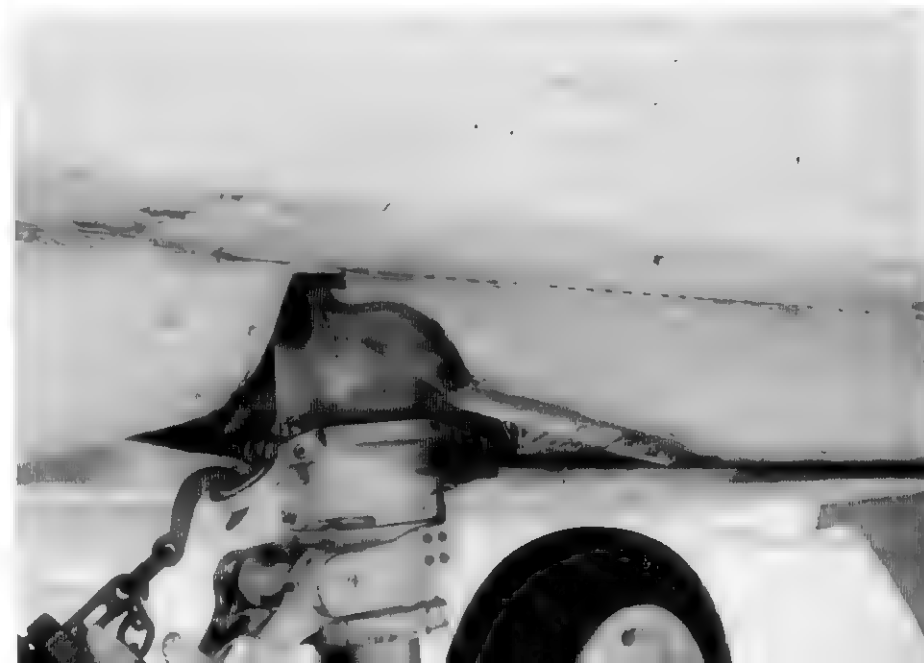
This RF-8G has the later solid nose landing gear wheel, which was incorporated during remanufacturing. Both access doors for camera stations 2 and 4 were hinged at their forward edges. These doors provided access for camera maintenance and removal. Forward of camera station 2 is the engine time/temperature recorder access hatch. (Dann)

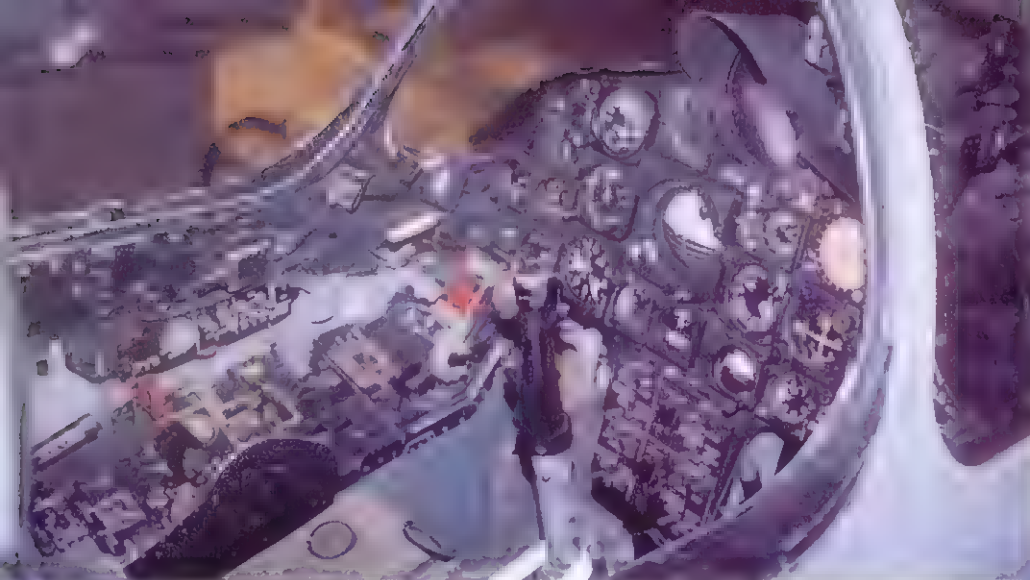
The RF-8 control stick utilized a single grip design similar to those on the F8U-1 (F-8A) through F8U-2 (F-8C). Roll and pitch trim control dials were located atop the grip. The Red trigger in front of the grip operated the camera when set in the manual control mode. The Red extra exposure button was mounted on the left side, while the nose gear steering button was on the bottom. Immediately in front of the control column was the Black adjustable position rudder pedal control knob. (Author)

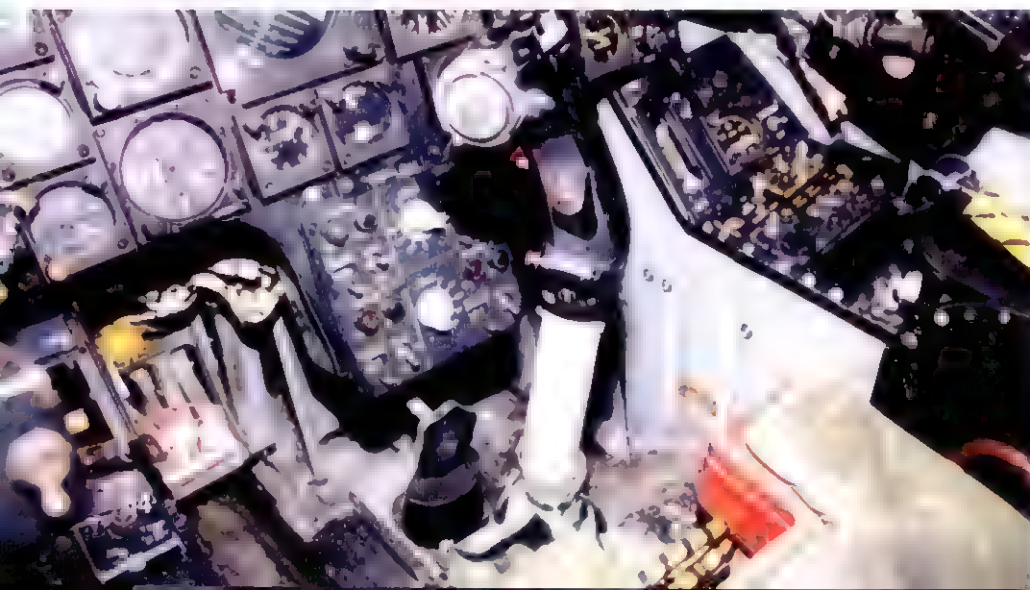
The RF-8's left console was the same from the throttle quadrant forward as on F-8 fighters. Aft of the throttle was the chaff control panel, camera master control panel, AN/ALR-45 disable panel, flare release panel, and the ventilation/oxygen distribution panel. The chaff reset switch is located in front of the canopy locks hinge. The panel below it contained the Tactical Air Navigation (TACAN) select switch, camera exposure control, speech security control, and exterior light switches. (Author)

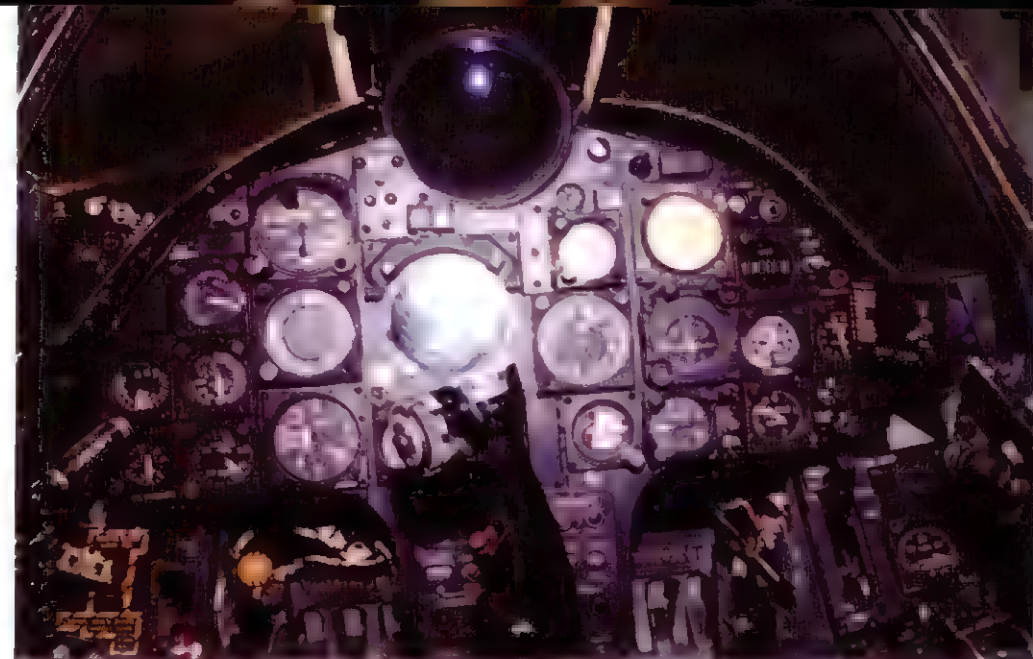
The RF-8 instrument panel differed from those installed on the fighter variants. The artificial horizon indicator was moved from the center to the left. Instruments immediately to the left (from top to bottom) include the radar altimeter, airspeed indicator, and altimeter. Instruments in the next column to the left include the angle of attack indicator, tachometer, and engine pressure ratio indicator. The instruments to the right of the horizon indicator are the aircraft clock, TACAN, and standby altitude indicator. (Author)

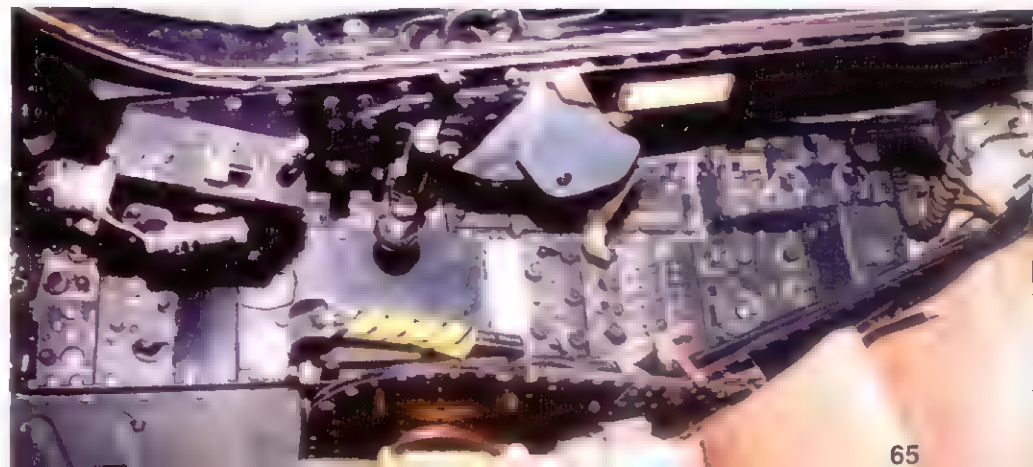
The RF-8 right console's front section was the same as on F-8 fighters. The aft section contained the UHF control panel, Identification Friend or Foe (IFF) control panel, TACAN panel, and compass panel. Interior cabin light controls are mounted on the raised panel at the rear. The Electronic Countermeasures (ECM) panel is on a box in front of the canopy actuator handle. The pouch on the canopy rail held the canopy gust support. (Author)

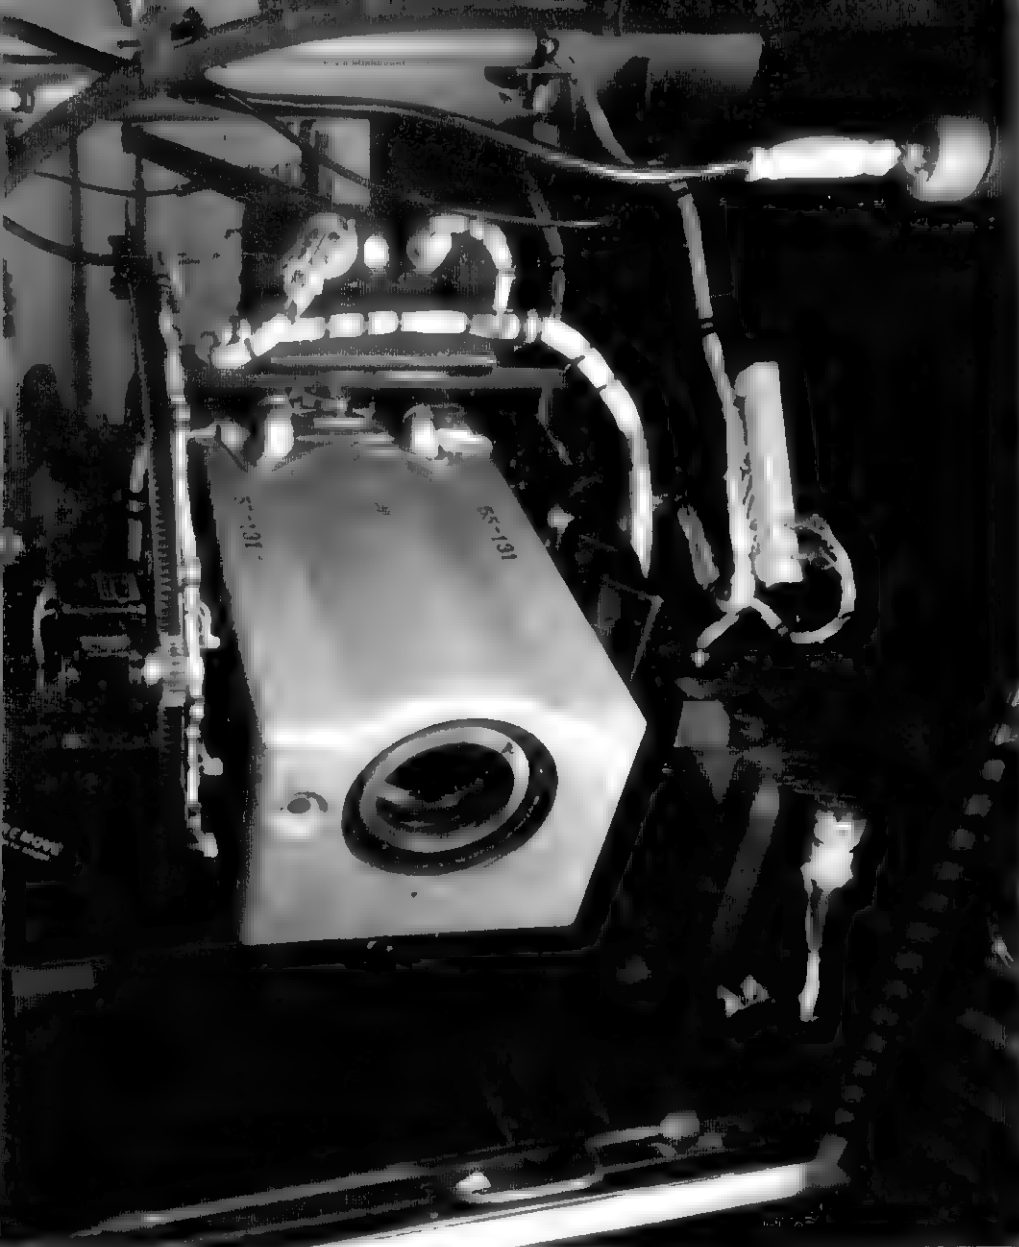
The Chicago Aerial CAX-12 oblique mounted camera could be mounted in camera stations 2, 3, and 4. This camera is mounted in station 4 on a rotatable mount at a 15° oblique angle. The CAX-12 had a variable lens focal length of 1.5 inches (38mm), 3 inches (76mm), 6 inches (152mm), or 12 inches (305mm). It carried 100 feet (30.5 m) of 2.25-inch (57mm) wide film that yielded 400 images. (Detail & Scale)

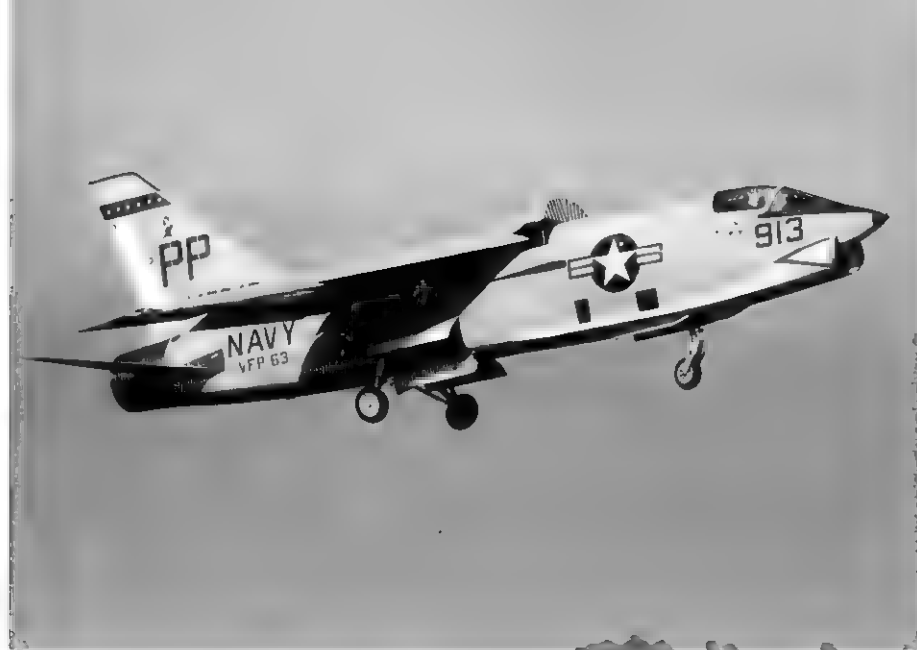
A VFP-63 RF-8A (PP-913/BuNo 146845) prepares to land at NAF Atsugi, Japan on 12 April 1963. Crusader reconnaissance variants employed the same variable incidence wing as the fighters. The RF-8A was not equipped with the aft fuselage ventral strakes, which were installed on the RF-8Gs (remanufactured RF-8As). (Matsuzaki)

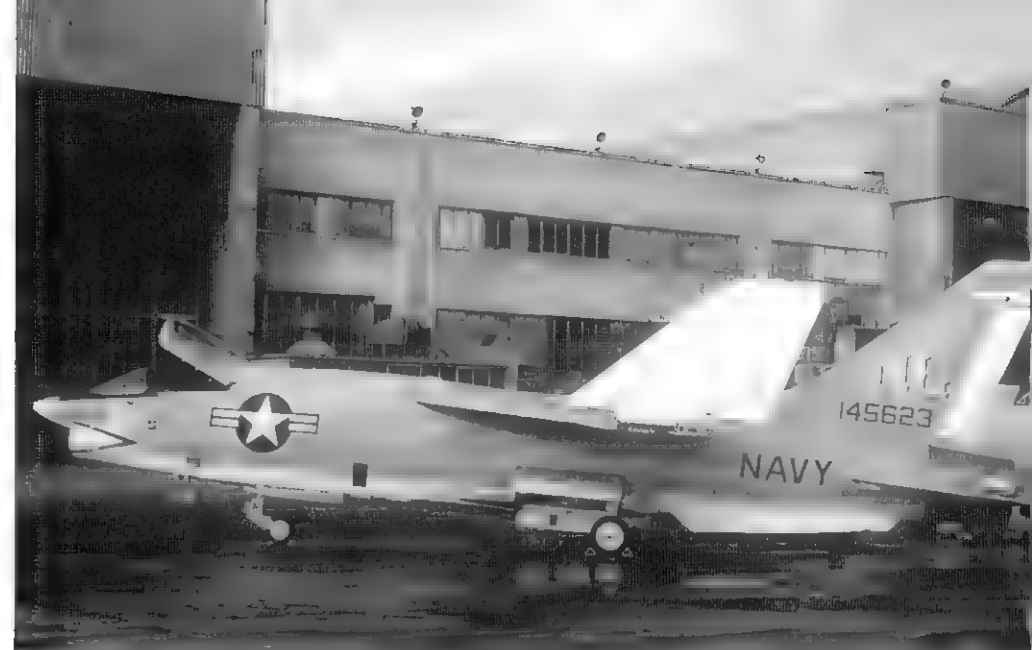
This RF-8G (NL-611/BuNo 145623) was assigned to VFP-63 at NAS Miramar, California. The Crusader has the streamlined ECM fairing on the vertical tail and the new, strengthened landing gear. These were features of the second RF-8G configuration. (Trombecky)

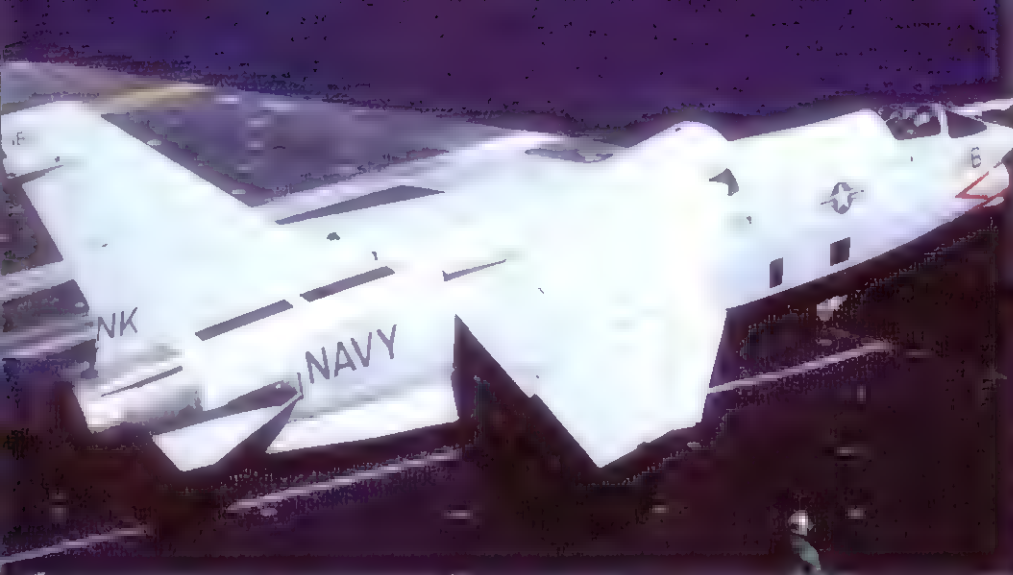
The right oblique (side) camera sight was mounted on the canopy frame. An identical assembly was fitted to the left canopy frame. The transparent Amber movable reticle was mounted in a ring connected to the canopy frame by a pantograph-style arm. This was the pilot's only aid in composing oblique photos. This photograph was taken through the canopy. (Nick)

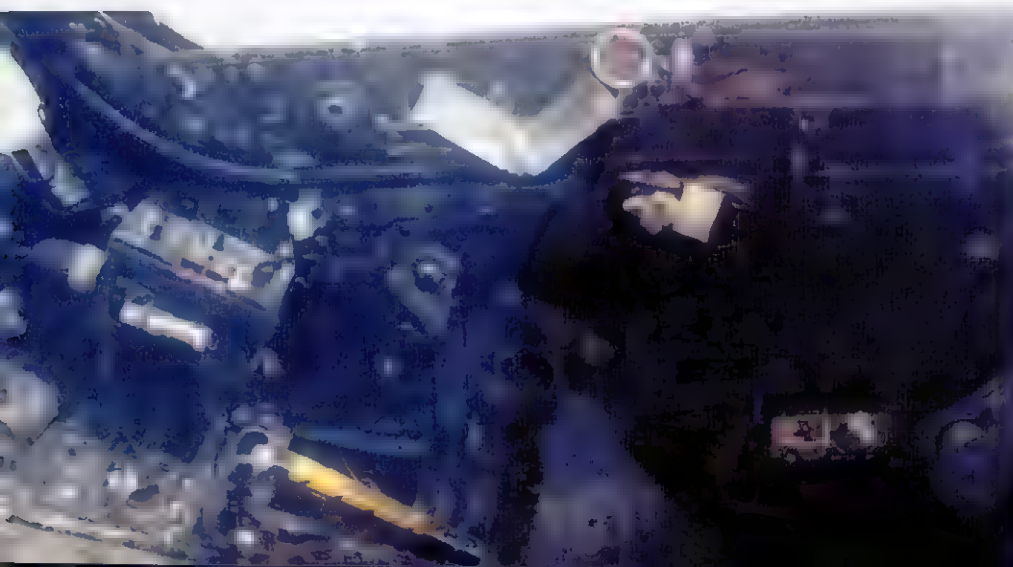
This RF-8G's nose compartment is opened to expose the viewfinder and dehydrator/filter assembly. This replaced the gun camera mounted in this position on F-8 fighters. The dehydrator dehumidified and circulated air in the viewfinder. These two lenses worked in conjunction with the 10" or 25" forward oblique cameras in station 1. (Detail & Scale)

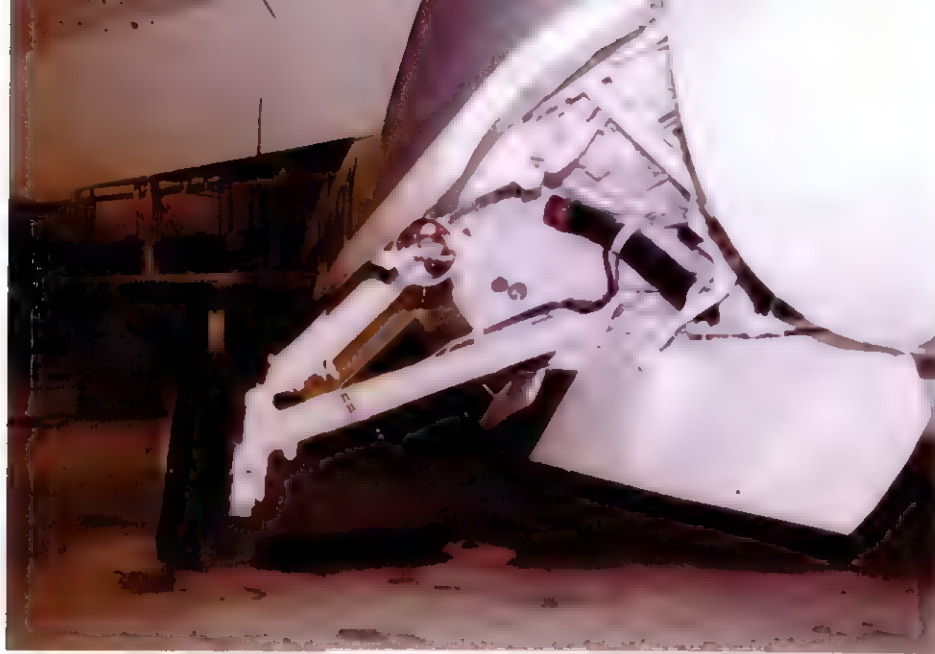
The RF-8's landing gear followed the same progression as on the F-8 fighters. A taxi light was mounted to the right side upper wheel well door. This RF-8G was direct from the paint shop and had yet to receive the Bright Red (FS31136) warning paint along the gear door edges. This aircraft is equipped with the later style strengthened landing gear. (Author)

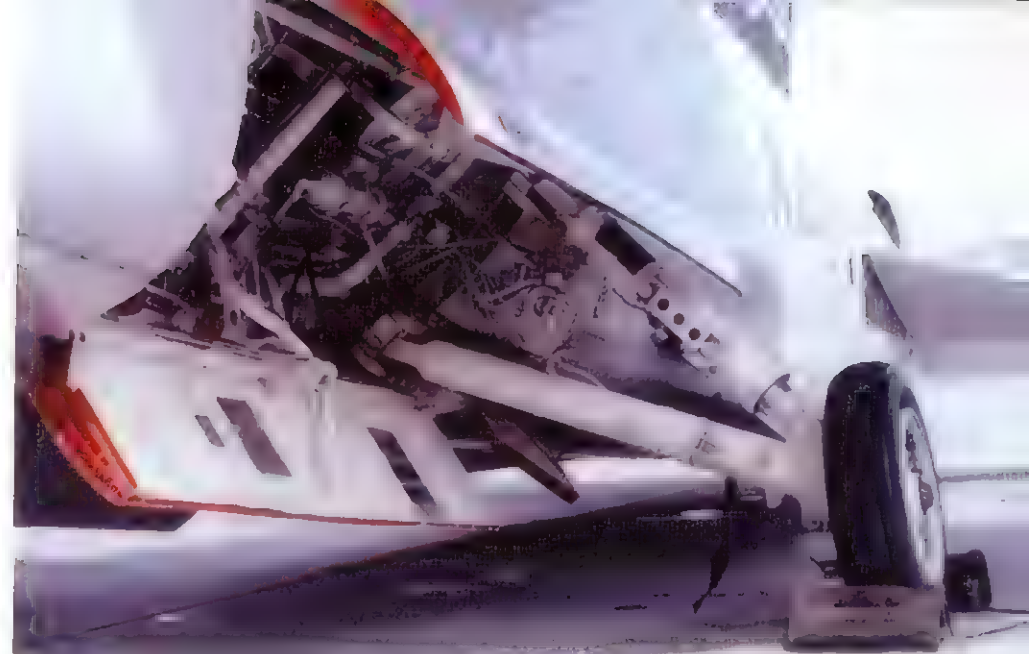
The RF-8's approach indicator was moved to the left landing gear shock strut. This was required because the housing for camera station 1 eliminated the front landing gear flipper door. The indicator lamps were (from top to bottom) Green, Yellow, and Red. This RF-8G is also equipped with the late style landing gear. (Trombecky)

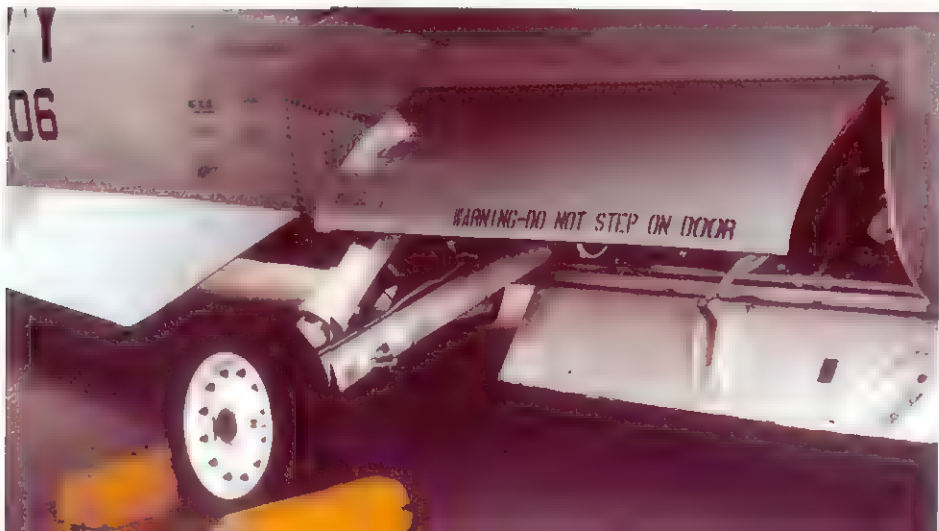
Reinforcement panels were added to both fuselage sides at the forward and aft corners when RF-8As were remanufactured into RF-8Gs. A single panel was added to the forward corner. Two plates added to the rear distributed the stresses transferred by the landing gear bulkhead. (JEM)

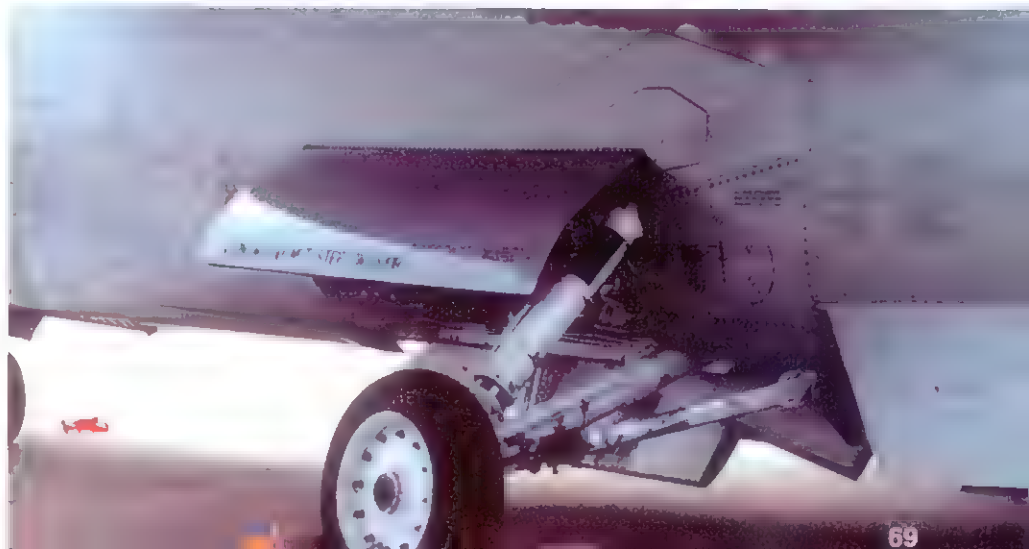
The RF-8G received the integral engine starter probe modification when it was remanufactured from RF-8A standard. The new style starter probe was identified by the left hinge's straight edge and it was located just aft of the left landing gear. (JEM)

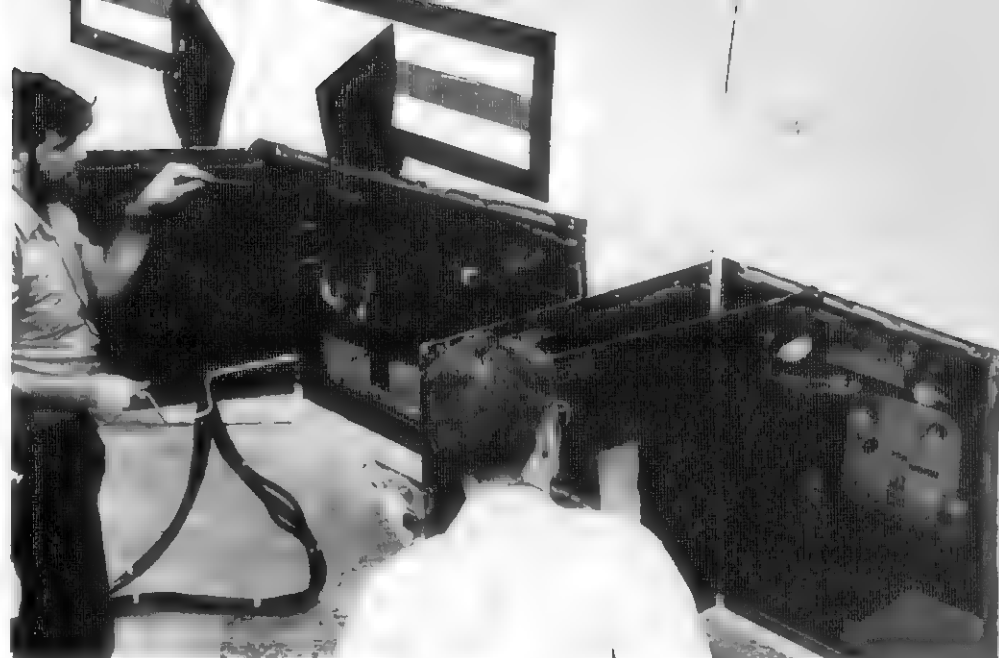
Two ground crewmen service cameras mounted in stations 2 and 3 on this VFP-306 RF-8G. The RF-8A's four camera stations were unchanged when these aircraft were remanufactured to RF-8G standard between 1965 and 1970. A vertically mounted camera is mounted in station 3. (US Navy)

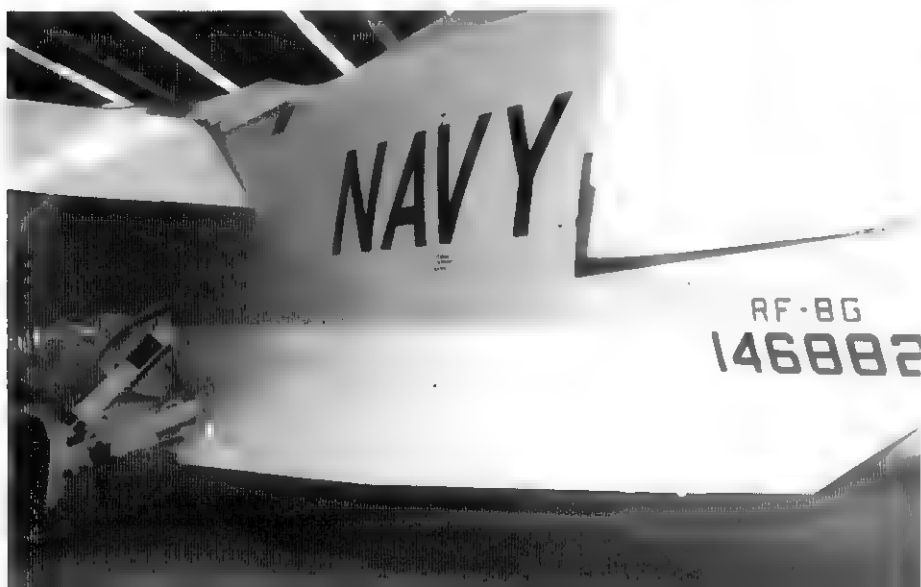
The RF-8G received the more powerful J57-P-20 engine and the aft fuselage ventral strakes, which enhanced high speed stability. These strakes ran along the right and left lower aft fuselage sides in the same fashion as those on the F8U-2 (F-8C) and later fighter variants. (Author)

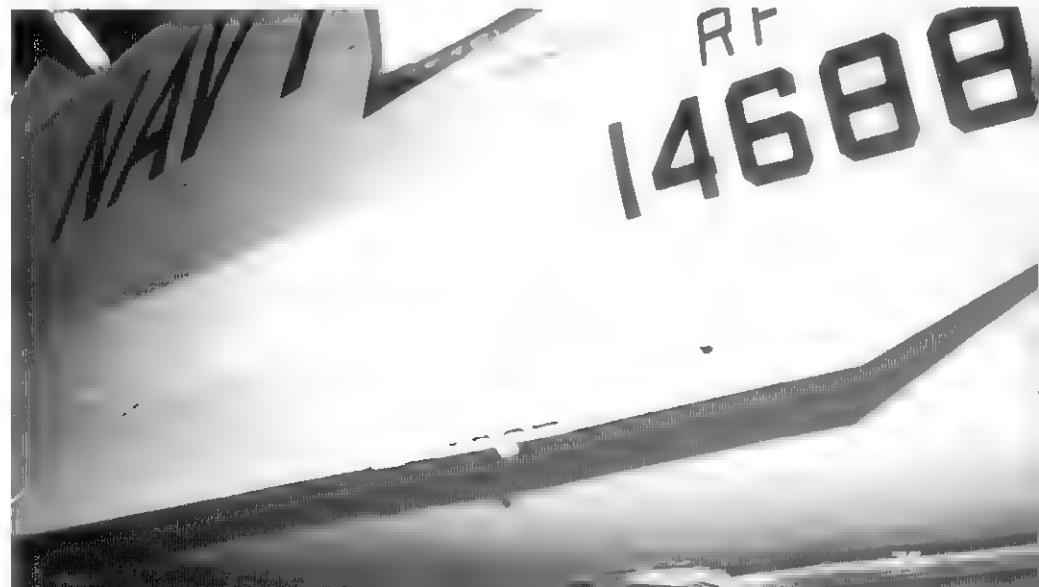
The fuselage fuel dump mast was incorporated into the left ventral strake's aft section. These strakes were divided into fore and aft sections, which accommodated the removable aft fuselage for engine maintenance. This configuration was used on both reconnaissance and fighter Crusaders. (Author)

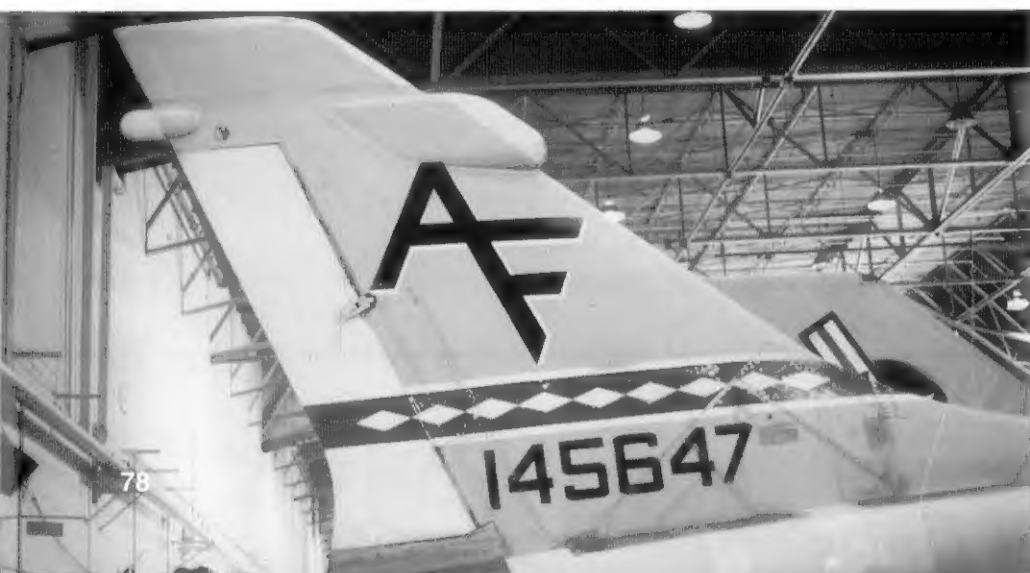
RF-8s had three different vertical tail antenna configurations. The first consisted of a fin without an antenna fairing. This RF-8G (BuNo 145647) demonstrates the second configuration, which was developed to accommodate the 'Shoe Horn' Electronic Countermeasures (ECM) system. The system included a small cylindrical antenna on the aft tail section and a large rectangular antenna fairing on the fin's leading edge. (Trombecky)

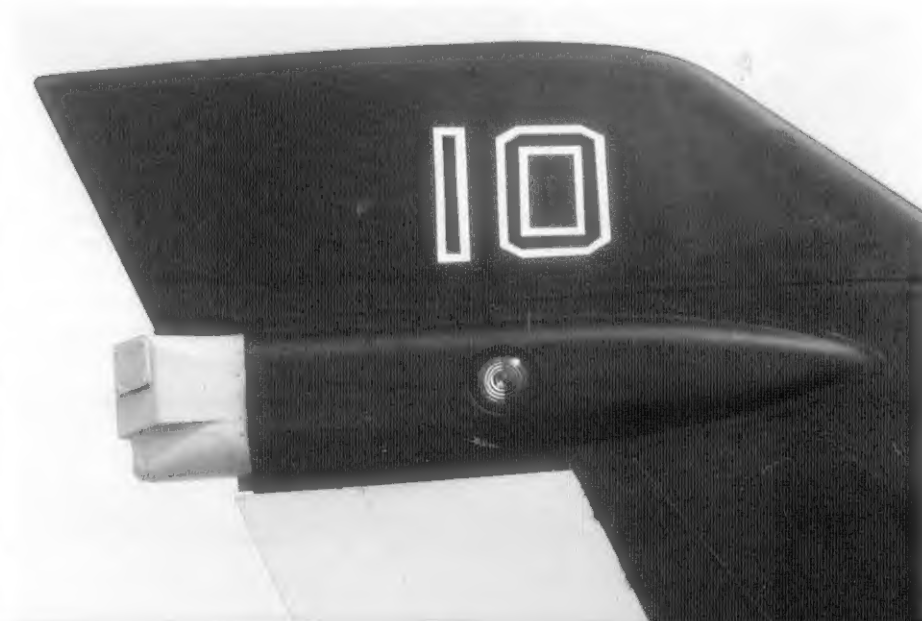
The final RF-8 tail configuration had a streamlined tapered antenna fairing mounted above the rudder and extending aft. The White navigation light was mounted in this fairing. The fairing terminated with two rectangular pads mounted at 45° angles with square sensors mounted on the outer face. (Trombecky)

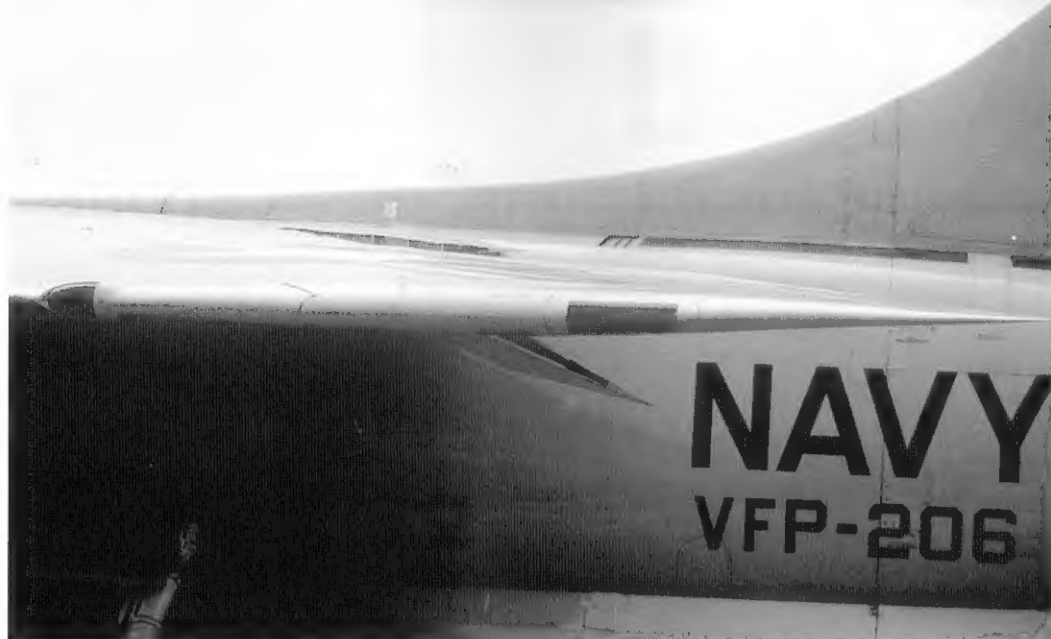
The RF-8's wing and wingtip configuration was the same as for the Crusader fighters. The left wing has Red lenses illuminated by bulbs within the lens covers. One light was mounted at the outer forward corner, while a second light was located toward the wingtip's aft end. (JEM)

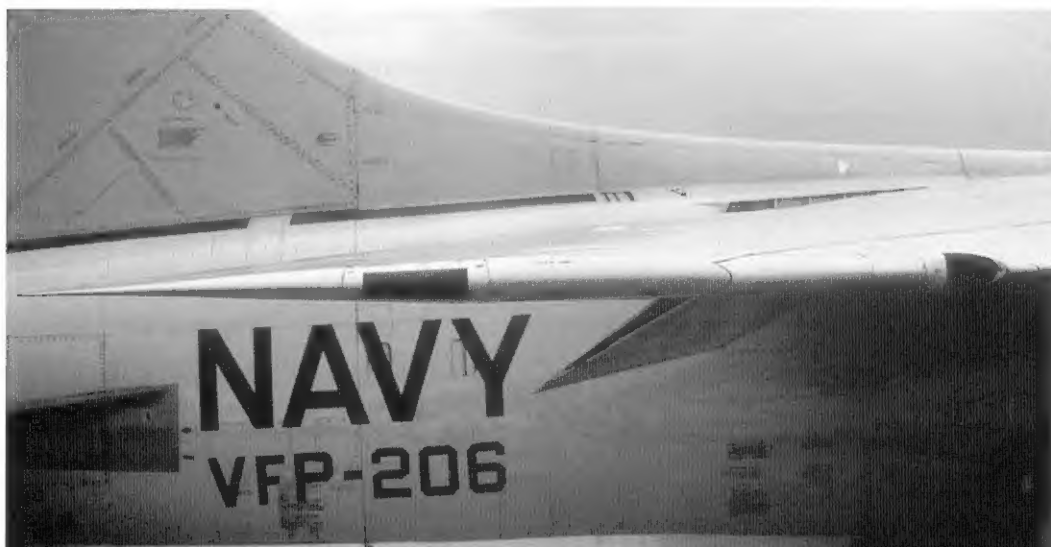
The right wingtip was similar in configuration to the left, except for the color of the lenses. The forward lens was Green, while the wingtip formation light was Blue. The wingtip upper surface had inward facing NO STEP warning stencils, while the underside had outward facing NO PUSH warnings. Both were directed at maintenance personnel and others near this aircraft. (JEM)

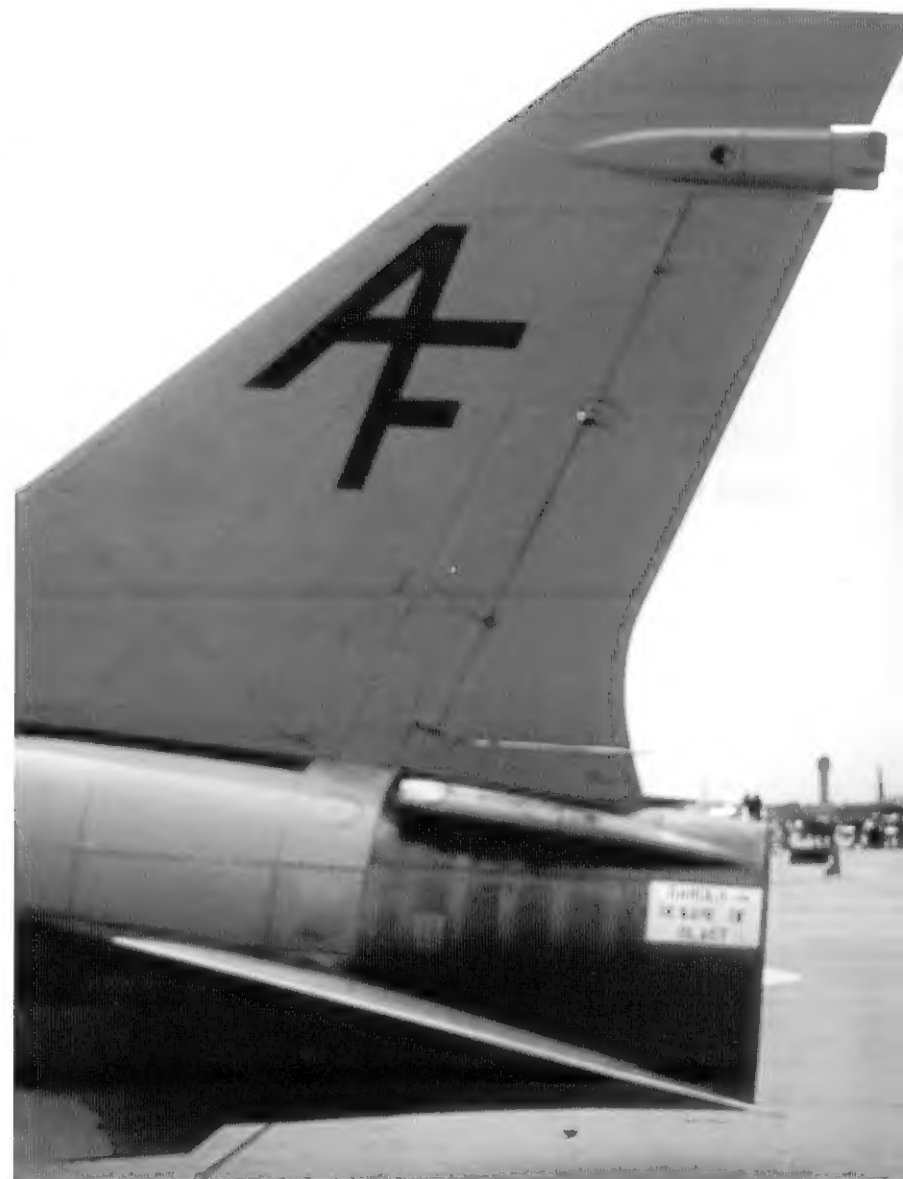
The RF-8's vertical tail was basically the same configuration as on the F-8; however, the aft facing ECM fairing atop the RF-8's rudder had a different configuration. The area behind the Unit Horizontal Tail (UHT) was often left unpainted because the fuselage expanded at elevated temperatures and rubbed against the UHT. (JEM)
